HK Pipelines

Journey to the Center of Des Moines

Summer 1996

By Andy Meral, CEO

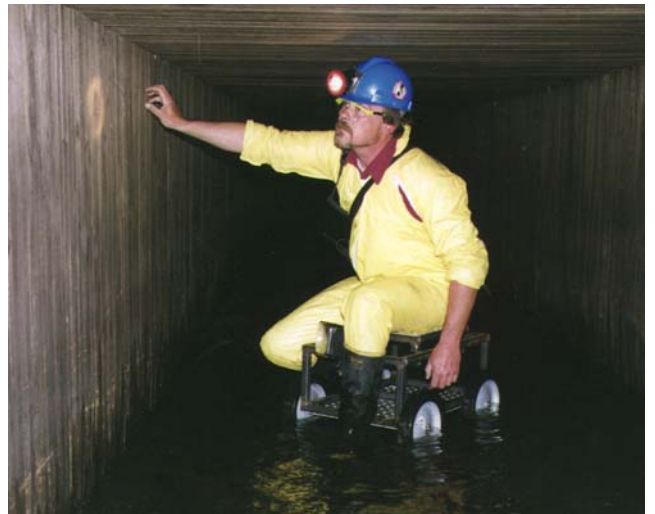
HK Sr. Service Technician, Kim Krebs, creeps along a specially made cart, while inspecting the wooden structure of an old storm sewer beneath the streets on the east side of Des Moines.
