HK Pipelines

Journey to the Center of Des Moines

Summer 1996

By Andy Meral, CEO

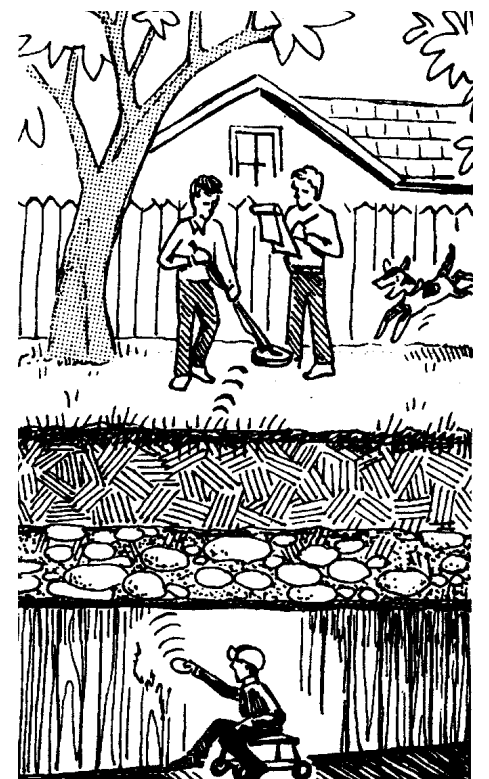
With the exception of a few areas that were piled up with rocks, gravel, and silt, the storm sewer was, for the most part, able to convey a considerable percentage of its flow capacity. The structure, however, has places that are weak and will need repair in the near future.
