HK Pipelines

Hydro-Klean Removes 1,350 Tons of Debris from DSM Sewer

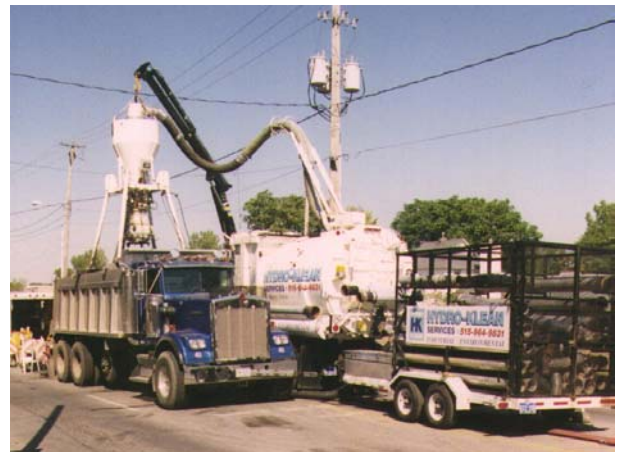
HK Industrial Vacuum With Detachable Cyclone

The equipment Hydro-Klean used was an industrial vacuum machine that has a lot more power than conventional sewer cleaning equipment. The biggest advantage of this equipment was its
